Steel Arm Bracket Assessment

NEETRAC Project Number: 11-120

July, 2011

Requested by: _____ Buddy Phillips
Georgia Power

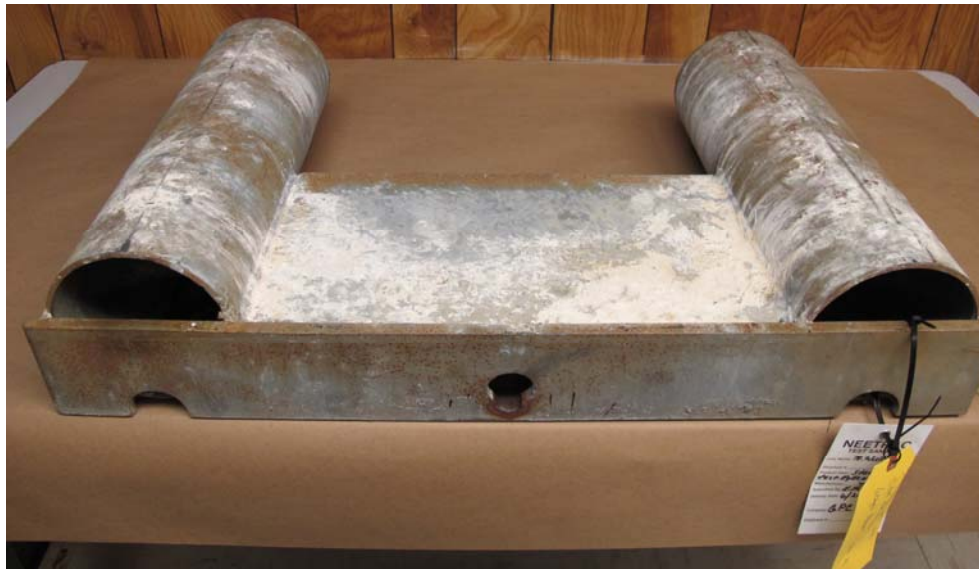
Figure 1: The as-received condition of Sample 1-1. The bushing was removed to show the condition of the eye.

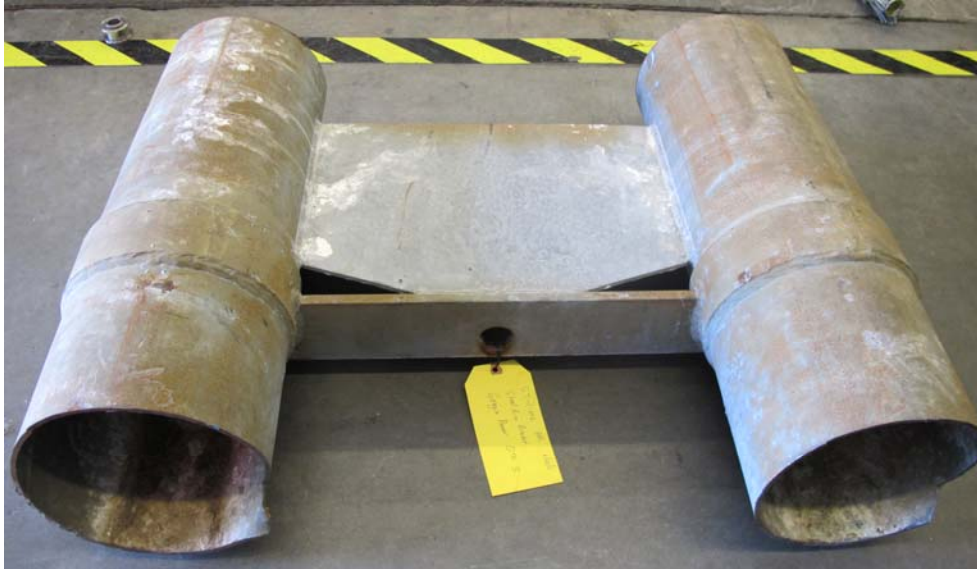
Figure 2: The as-received condition of Sample 1-2. The bushing was removed to show the condition of the eye.

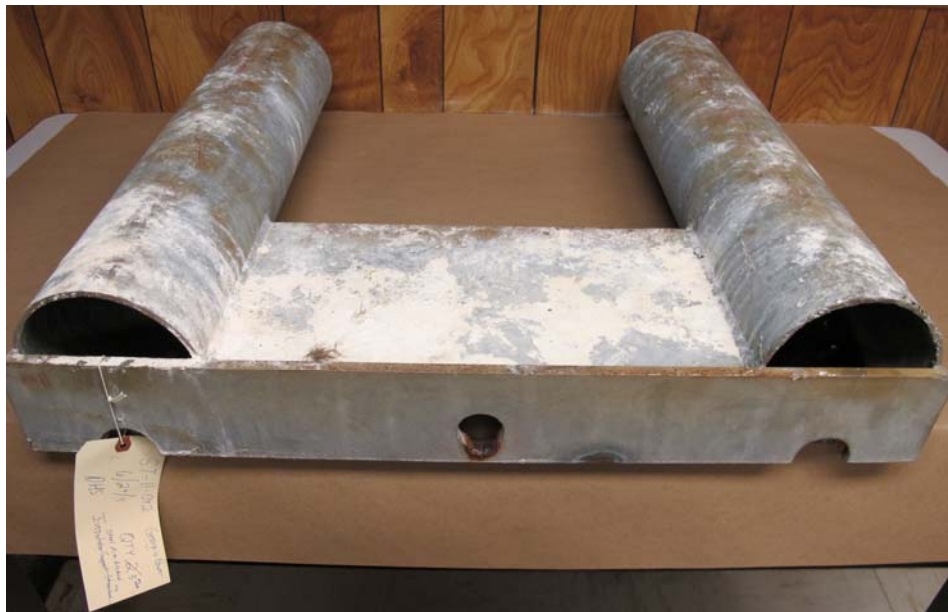
Figure 3: The as-received condition of Sample 1-3. The Y-bolt was removed to show the condition of the eye.

Visual and dimensional examinations were performed on the samples. The sample with the least material distance between the wear of the eye and the edge of the front plate, Sample 1-3, was tested with only a Y-bolt through the eye. The remaining two samples were tested with bushings and a Y-bolt through the eye of the samples. The three samples were cut to fit into the Tinius

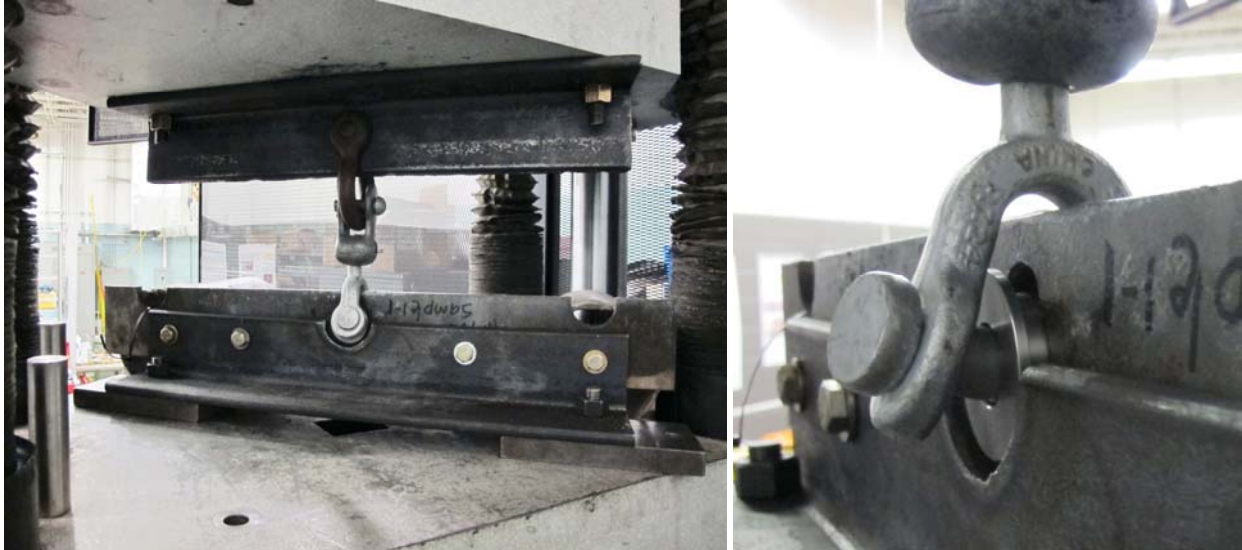
Figure 4: Test setup of Sample 1-1 and a close-up of the bushing and Y-bolt in the eye.

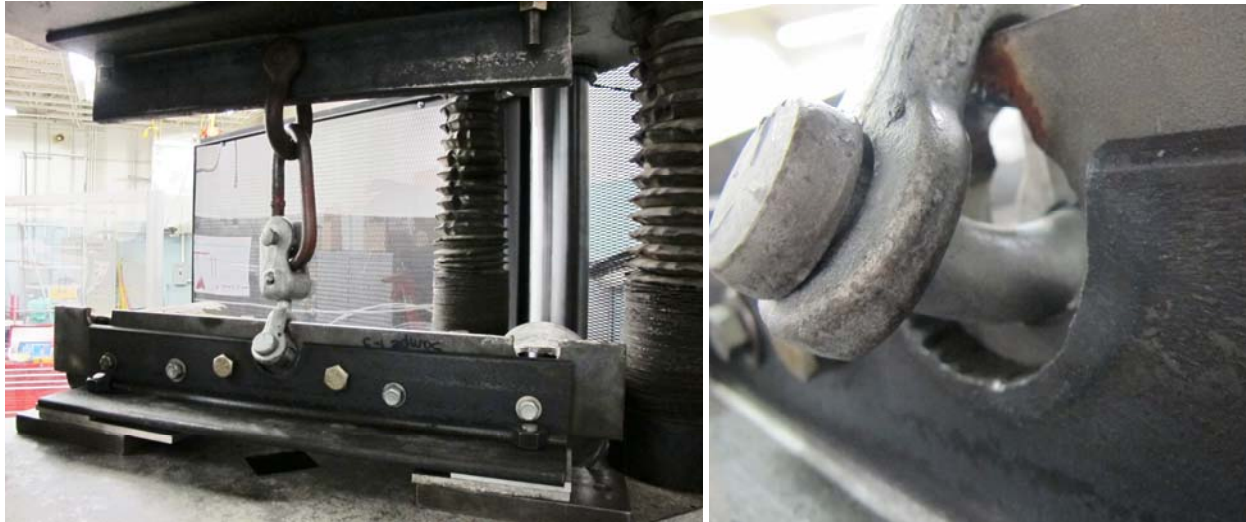
Figure 6: Test setup of Sample 1-3 and a close-up of the Y-bolt in the eye.

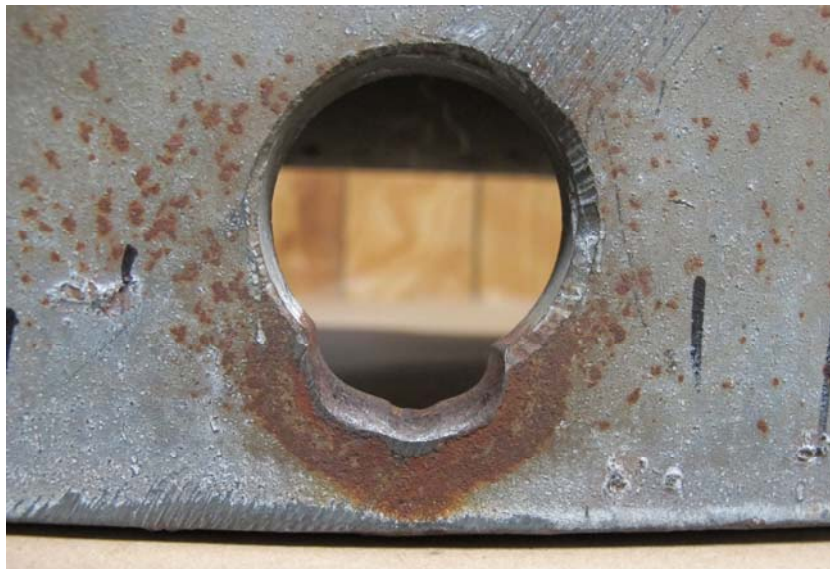
All three samples showed signs of corrosion and wear in the eye. A close-up view of the condition of the eye of each sample can be seen in Figures 7 through 9.

Figure 7: The as-received condition of the eye of Sample 1-1. The material appears to have yielded though the excess material seems to have been chipped off of the front of the eye. The wide area of wear suggests that the Y-bolt may have been rocking and swaying over an extended period of time in the field.

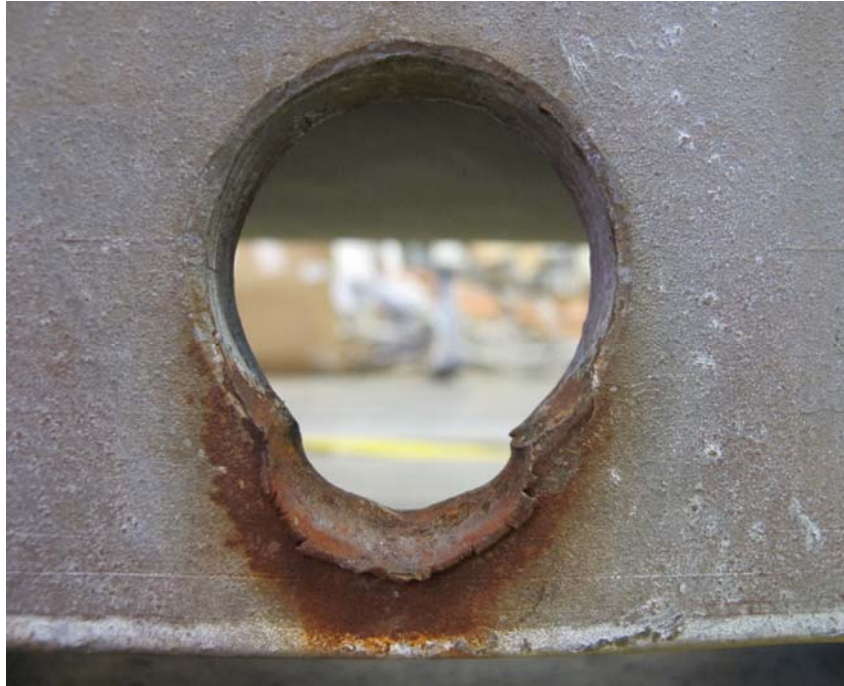
Figure 8: The as-received condition of the eye of Sample 1-2. The material appears to have yielded as there is an excess of material displaced at the edge of the wear of the eye. The wide area of the wear suggests that the Y-bolt may have been rocking and swaying over an extended period of time in the field.

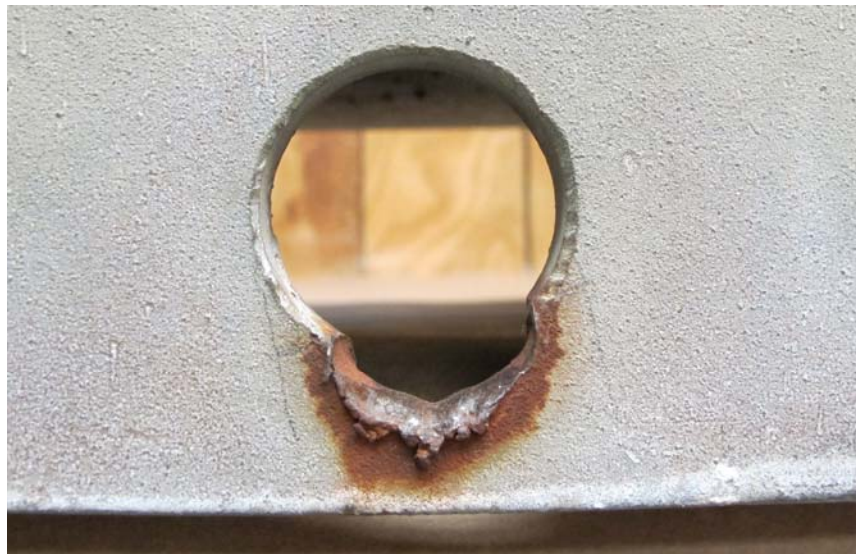
Figure 9: The as-received condition of the eye of Sample 1-3. The material appears to have yielded as there is an excess of material displaced at the edge of the wear of the eye. The wide area of the wear suggests that the Y-bolt may have been rocking and swaying over an extended period of time in the field.

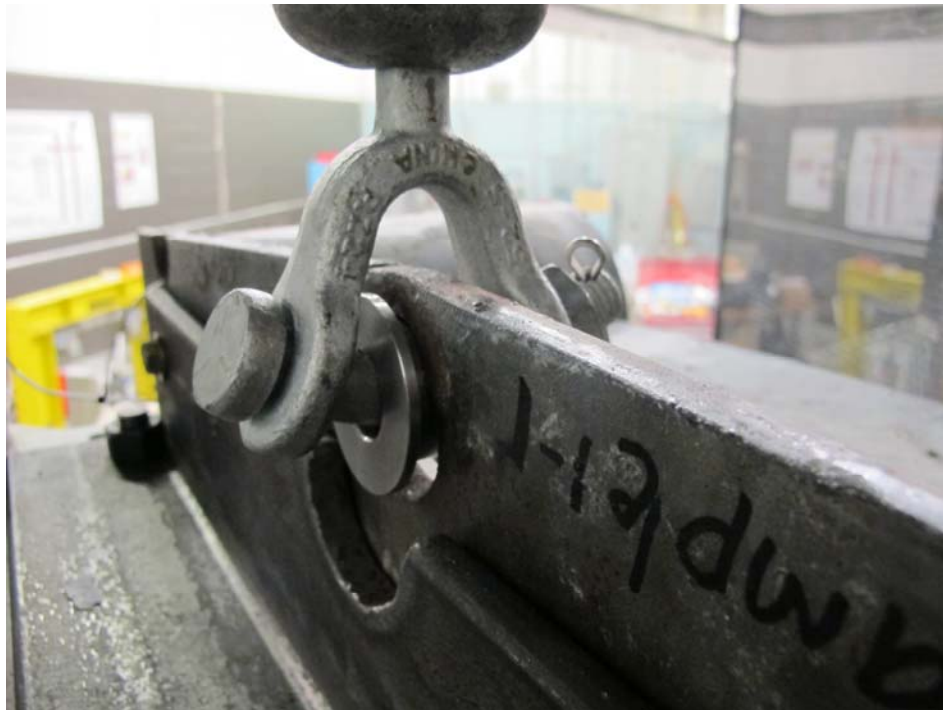
Table 1: Ultimate Tensile Strength Test Results			
Sample #	Material Distance Between Eye Wear and Plate Edge	Breaking Load	Failure Mode
	[in]	[lbs]	
1-1 Bushings 1	0.6230	22,996	Fixture bolts shear failure. Eye deformed but did not shear.
1-2 Bushings 2	0.5535	25,211	Y-bolt clevis tensile failure. Eye deformed but did not shear.
1-3 Y-bolt	0.5230	20,895	Shear tear out of eye from Y-bolt.

Figure 10: Sample 1-1 deformation after shear of inside bolts of fixture. The eye deformed but did not shear.

Sample 1-1 was pulled to 22,996 lbs during the ultimate tensile strength test and deformed but did not result in a shear tear out of the eye. Sample 1-2 was pulled to 25,211 lbs during the ultimate tensile strength test and deformed but did not result in a shear tear out of the eye. Sample 1-3 was pulled to 20,895 lbs during the ultimate tensile strength test and resulted in a shear tear out of the eye.

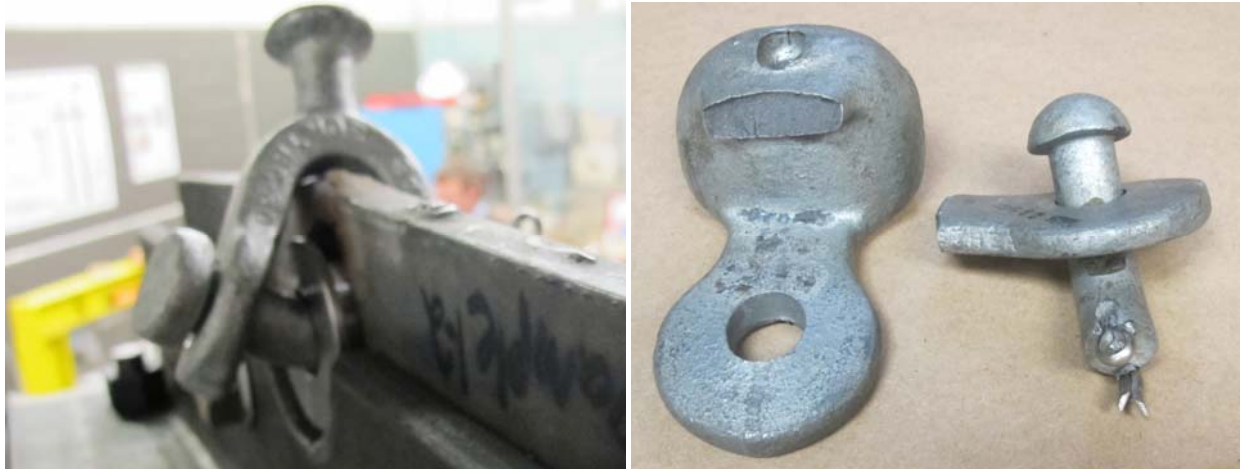
Figure 11: Sample 1-2 deformation after failure of socket of Y-bolt and a close-up of socket failure. The eye of the sample deformed but did not shear.

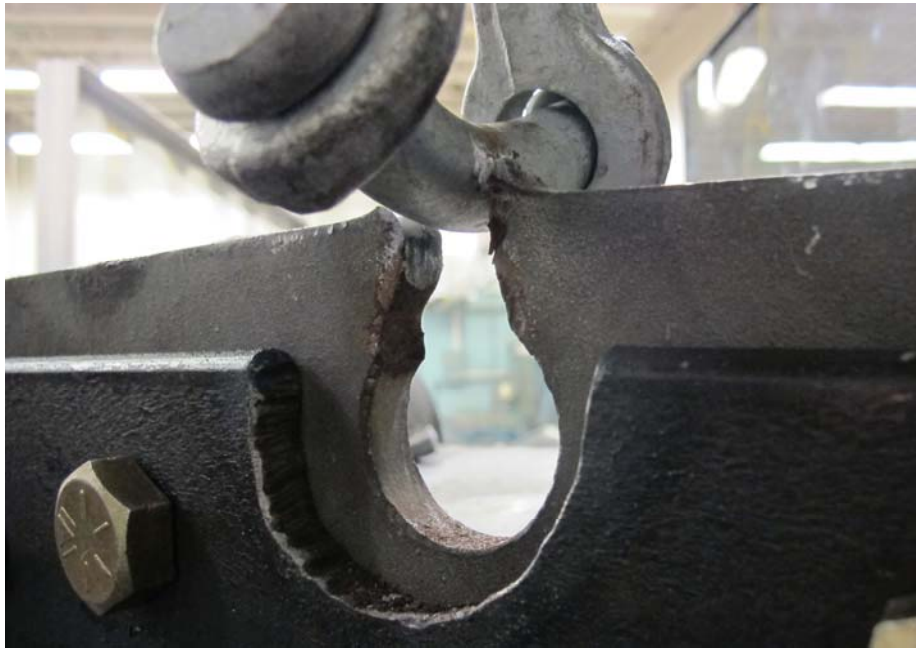
All three samples deformed during the test. Sample 1-3 resulted in a shear tear out of the eye from the Y-bolt. The results from the ultimate tensile strength test of each sample can be seen in Table 1. The deformation for each sample can be seen in Figures 10 through 11.

Figure 12: Sample 1-3 failure and shear tear out from Y-bolt.
