# Arm Attachment Bushing

## “Buddy Bushing”

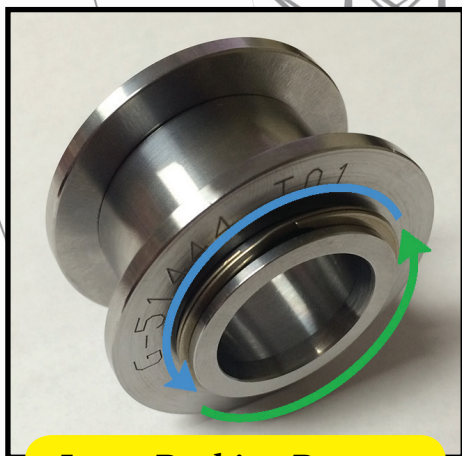
Inner Bushing Rotates

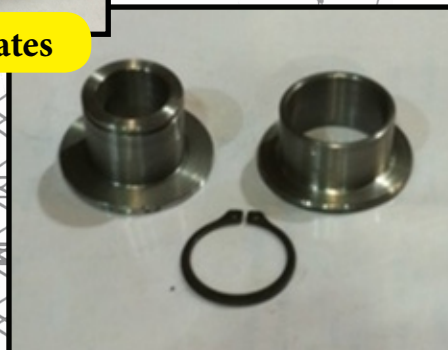
*The new bushing increased the strength of the clevis attachment by up to 25%*

Stainless steel Buddy Bushing was designed to eliminate the sawing action that was causing the insulator attachment hole to fail by allowing the inner bushing to rotate.

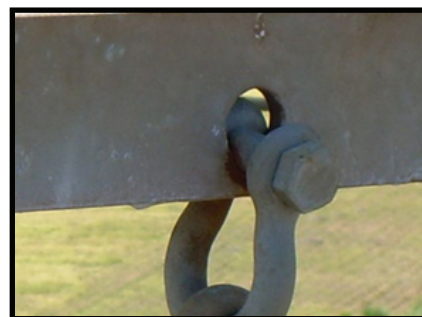
Over time, wind-driven rubbing between line insulator hardware and the associated cross arm attachment points can cause failure of the cross arm at the point of attachment.
